Power failure, restart and repair

Power outage may be partial or total, planned or unplanned. Time is an important parameter. Total loss of power for half an hour due to change of cathodes or minor repairs are no problem. Stop for two to four hours are manageable while five hours or more causes large problems with loss of cell life.

By Harald A Øye* and Morten Sørli**

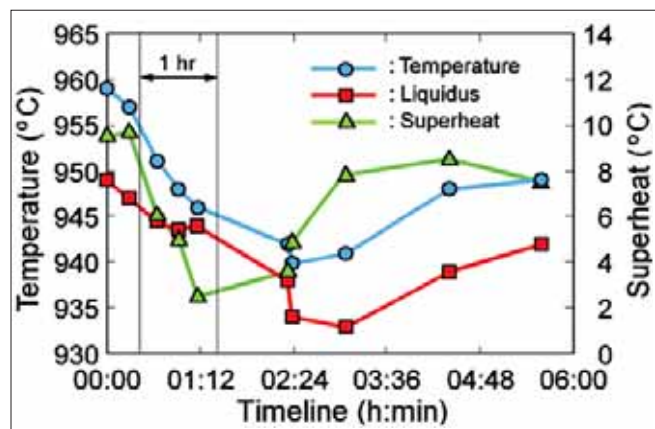
Fig 1 The development of bath temperature, liquidus temperature and superheat during and after a 1 hour shutdown. Source (5)

A time limit of three to four hours is applicable but recovery time increases substantially. **Fig 1** shows the development of bath temperature, liquidus temperature and superheat before, under and after a one hour full current interruption. The initial reaction is an instantaneous decrease of both bath temperature and electrolyte-liquidus temperature due to continuous heat losses without energy input.

During this period the energy balance causes a shift in the material balance due to excessive freezing of bath (ie cryolite), which results in an enrichment of AlF_3 (and Al_2O_3). After restart the superheat reacts immediately with an increase and stabilises at approximately its original value, while bath and liquidus temperature continue to drop for a while due to the change in bath chemistry.

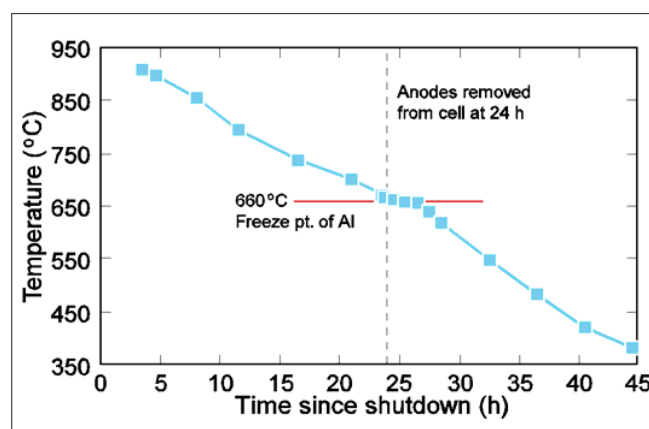
Fig 2 Aluminium temperatures measured in a cell after shutdown. The intersection of metal freezing and removal of anodes was coincidental. Source (6)

The electrolyte freezes at about $900^\circ C$ after four to five hours. The metal takes a considerably longer time to freeze, and is dependent on the depth of bath and metal pad [6]. In a small prebake cell with about 1600kg metal present, complete freezing of the metal took about 27 hours.

Anode removal after 24 hours may have a minor influence (**Fig 2**). Modeling results for a large prebake cell with about $2\frac{1}{2}$ cm of remaining bath and $7\frac{1}{2}$ cm metal showed that it took more than 24 hours for all the metal to solidify, while a similar size pot with about 20cm bath and 36cm metal needed more than three full days for the aluminium pad to turn 100% solid, provided that anodes were not removed in the meantime.

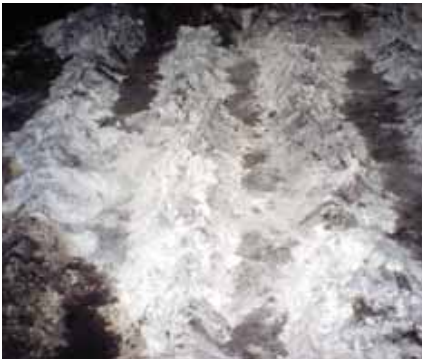
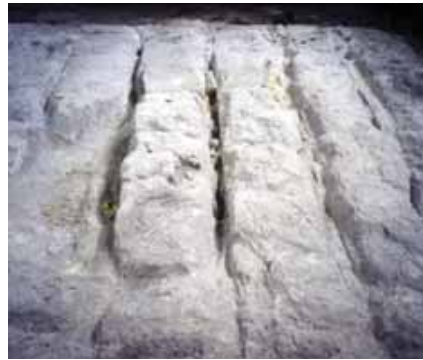
Fig 4 The result of exposing a cleaned cathode surface to air. a) Alumina powder formed by reaction between aluminium carbide and moist air. The ridges are reaction products being pushed up from the narrow joints. b) A view of the destroyed cathode surface after most of the powder has been removed

This results in a significant expansion of solids. **Fig 4a** shows the surface of a once cleaned cathode exposed to air for too long. The carbide oxidation produces a layer of very fine alumina covering the entire surface.

The parallel powder ridges seen in the photo mark the location of the narrow joints. They are likely to hold a higher carbide concentration. As the oxidation proceeds, it follows the carbide infiltration down into the joint and the fine-powdered alumina reaction product is pushed up.

In the process the carbide-infiltrated the baked ramming paste disintegrates and is pushed out of the joints together with the expanding alumina. In that process the edges of the bottom blocks are also broken off, resulting in a completely destroyed cathode (**Fig 4b**). This cathode was 468 days old and had a level surface without obvious damage when it was cleaned.
